**Missouri River Flood 2011  
Vulnerabilities Assessment Report  
Volume II-Technical Report**

**Northwestern Division  
US Army Corps of Engineers**

**October 2012**

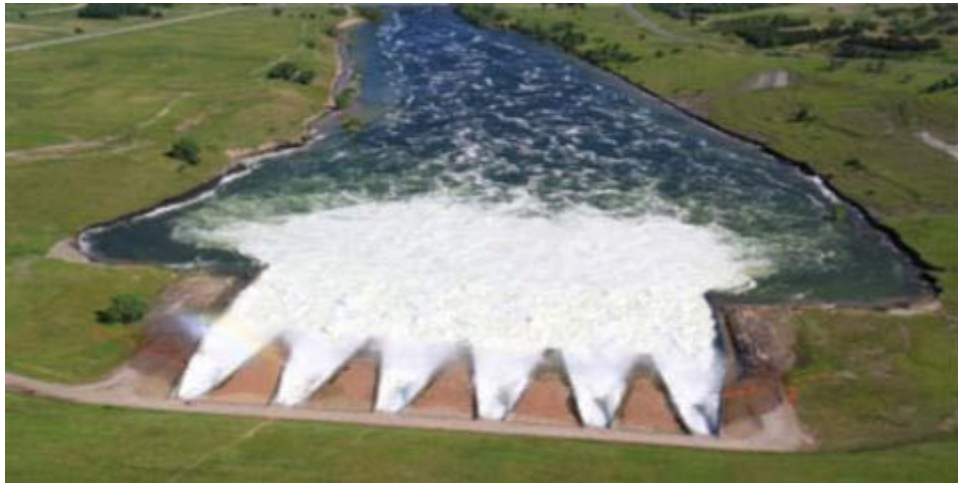
**Figure 80. Dams damage/erosion: Oahe - Erosion along the earthen walls extending from Oahe's stilling basin outside Fort Pierre, South Dakota**

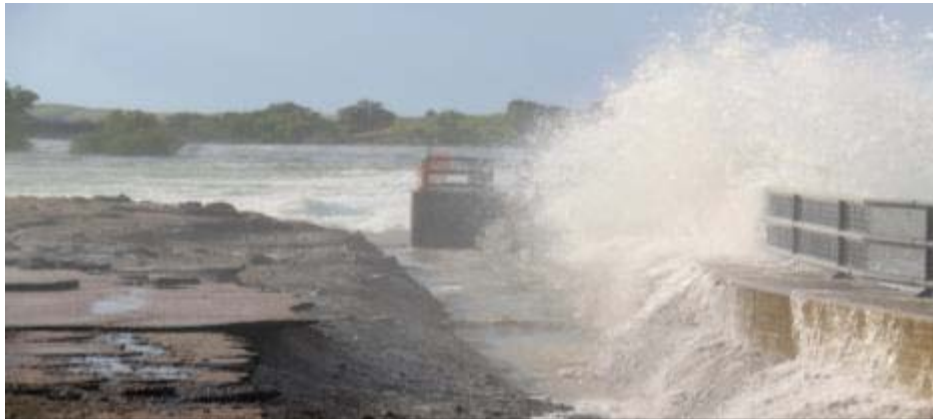
**Figure 81. Dams damage/erosion: Oahe**

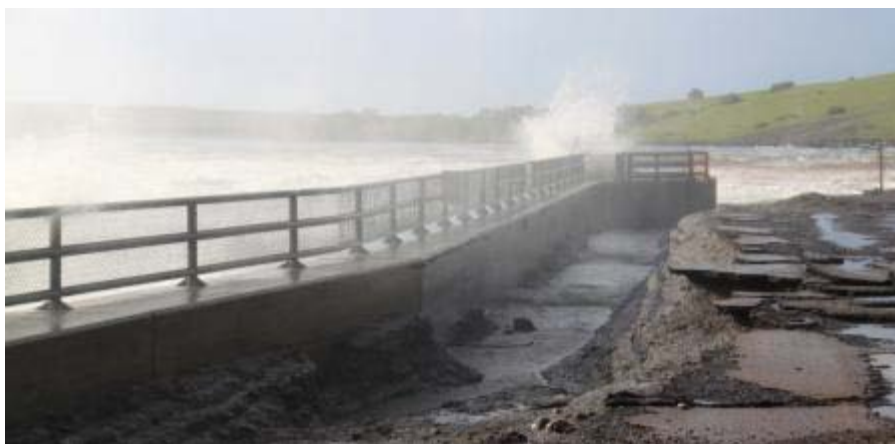
**Figure 82. Dams damage/erosion: Oahe - Erosion at flood tunnel outlet for Oahe outside Fort Pierre, South Dakota (under repair)**

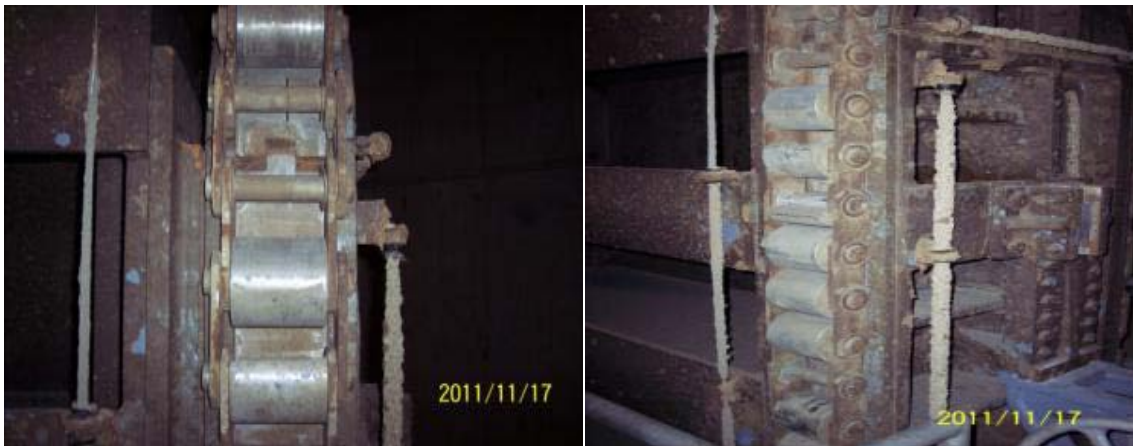
**Figure 83. Dams damage/erosion: Oahe - Flood control tunnel gate roller chain failure at Oahe outside Fort Pierre, South Dakota**

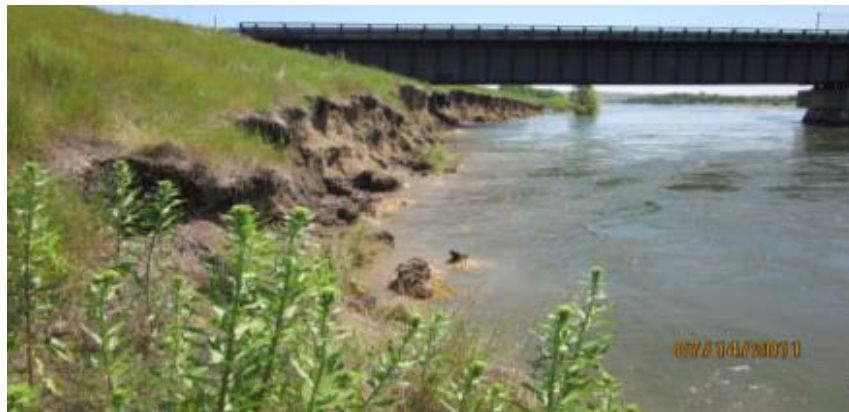
**Figure 84. Dams damage/erosion: Oahe - Outlet works bridge scour at abutment at Oahe, South Dakota**

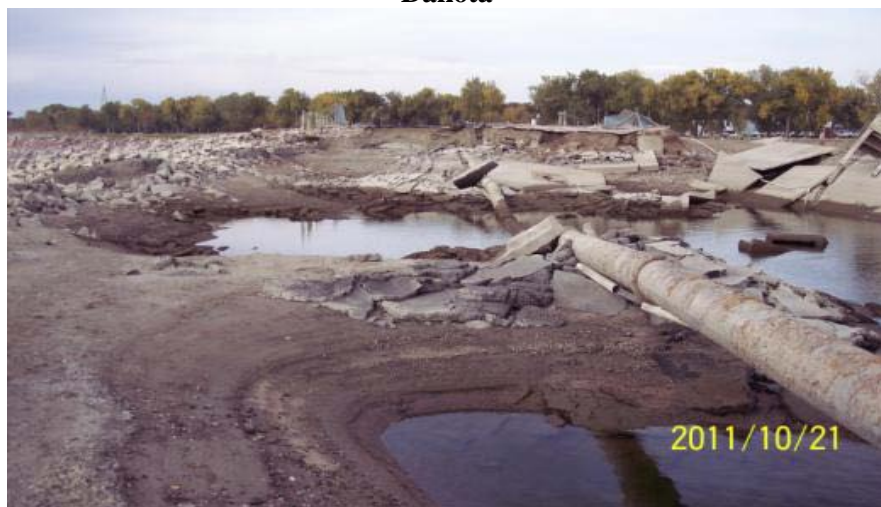
**Figure 85. Damage/erosion: LaFramboise Island Causeway - City of Pierre waterlines damaged at LaFramboise Island Causeway (Corps) in Pierre, South Dakota**

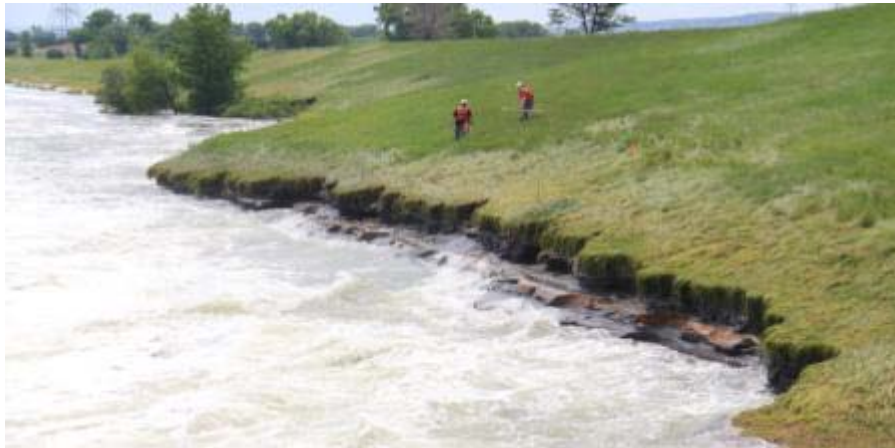
**Figure 86. Dams damage/erosion: Big Bend Erosion on earthen walls of the project's spillway in South Dakota**

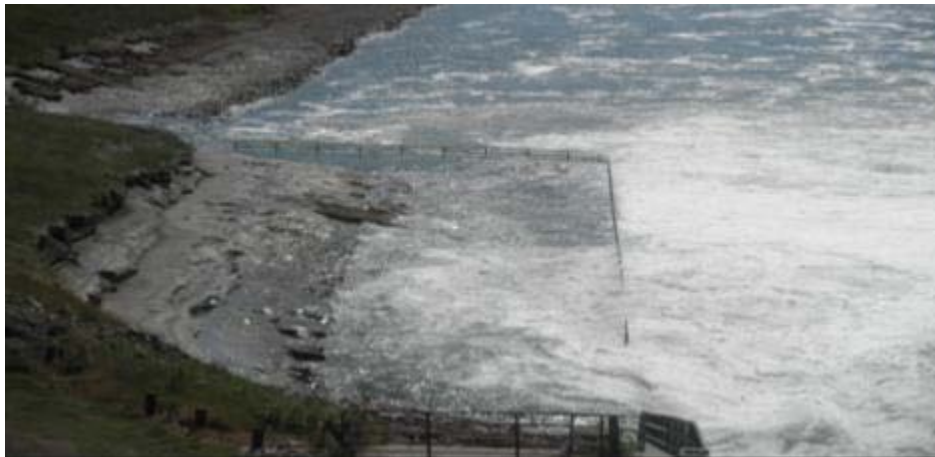
**Figure 87. Dams damage/erosion: Big Bend Erosion on earthen walls of the project's spillway in South Dakota**

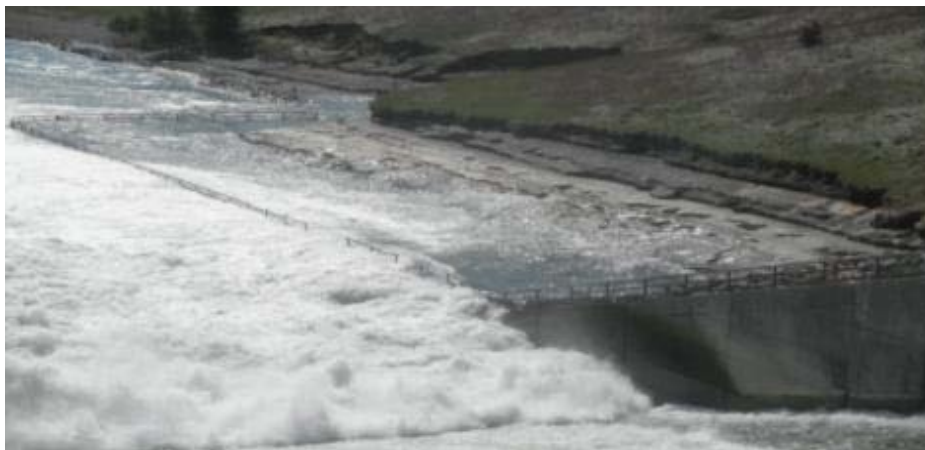
**Figure 88. Dams damage/erosion: Big Bend Erosion on earthen walls of the project's spillway in South Dakota**

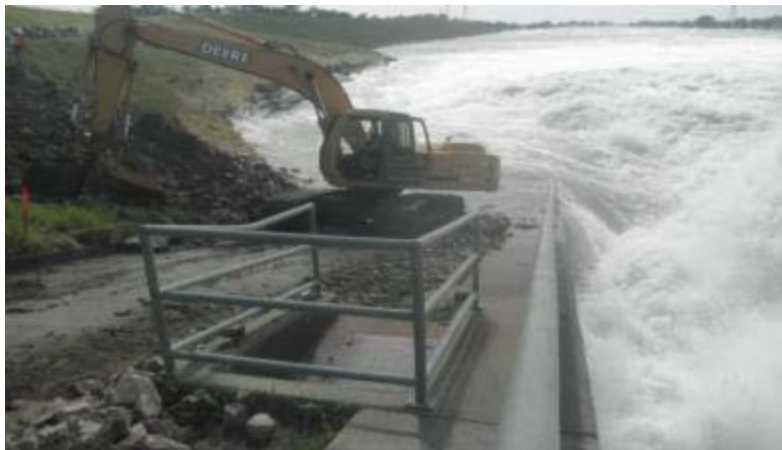
**Figure 89. Dams damage/erosion: Big Bend - Project's spillway in South Dakota being overtopped during flood**

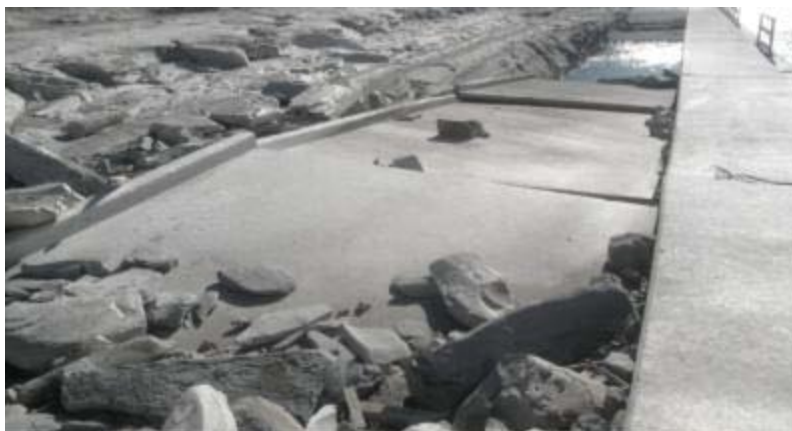
**Figure 90. Dams damage/erosion: Big Bend – Project's spillway overtopping damage in South Dakota currently under repair**

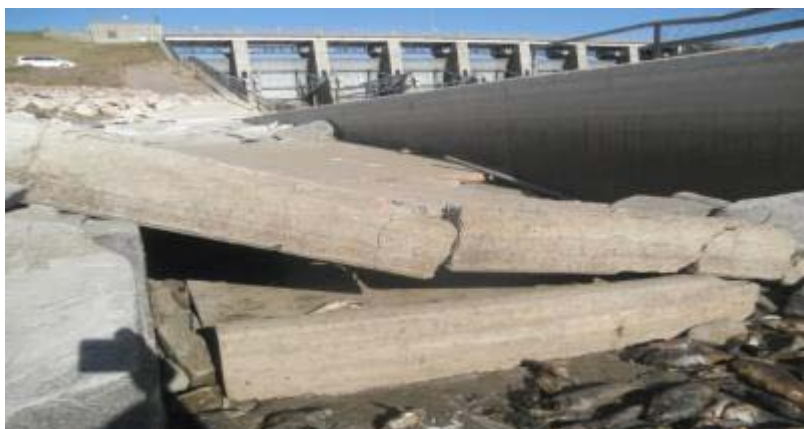
**Figure 91. Dams damage/erosion: Big Bend – Project's spillway overtopping damage in South Dakota currently under repair**

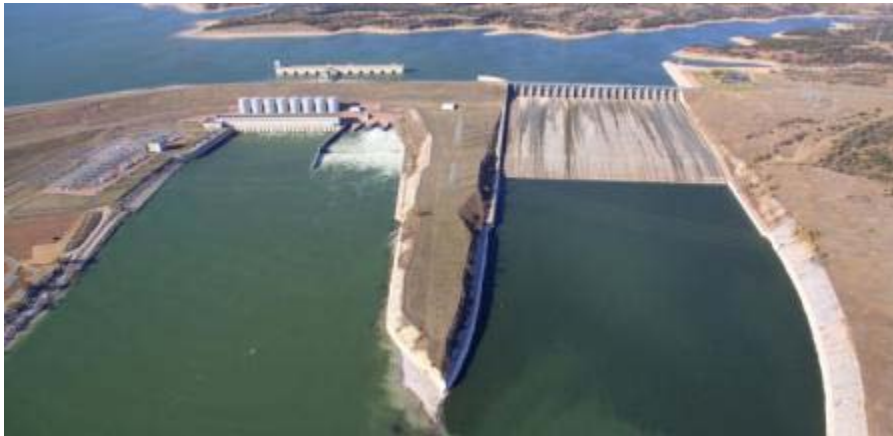
**Figure 92. Dams damage/erosion: Fort Randall - Sloughing on earthen walls of the project's spillway and regulating tunnels in South Dakota**

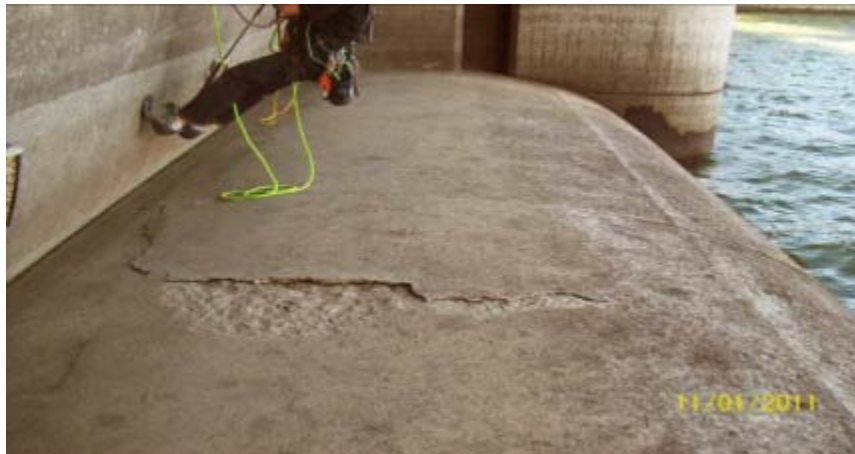
**Figure 93. Dams damage/erosions: Fort Randall - Spillway weir spalling**

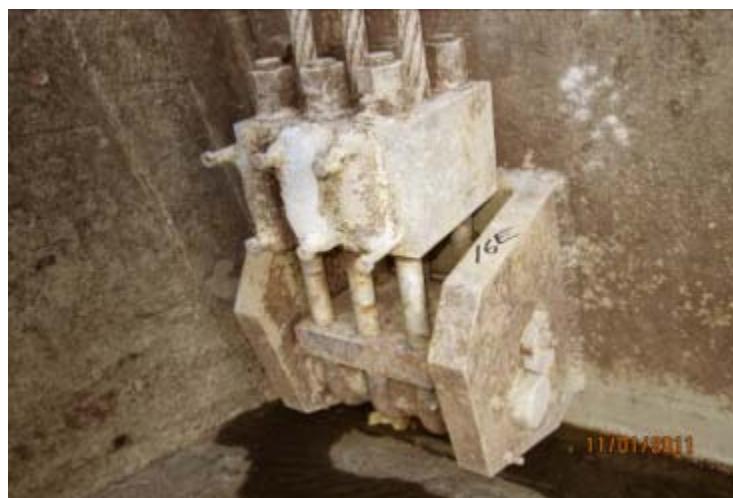
**Figure 94. Dams damage/erosion: Fort Randall - spillway gate wire rope hoist linkage corrosion**

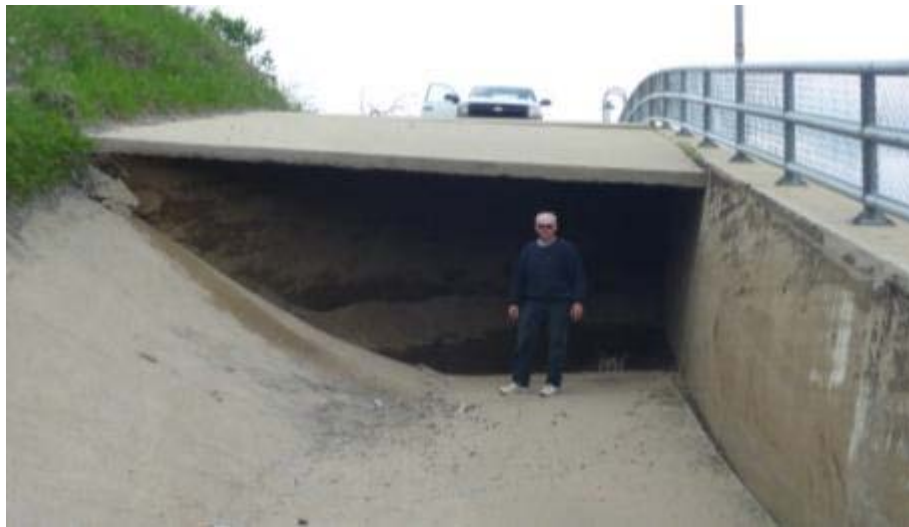
**Figure 95. Dams damage/erosion: Fort Randall - Spillway wingwall backfill erosion (currently under repair) at Fort Randall in South Dakota**

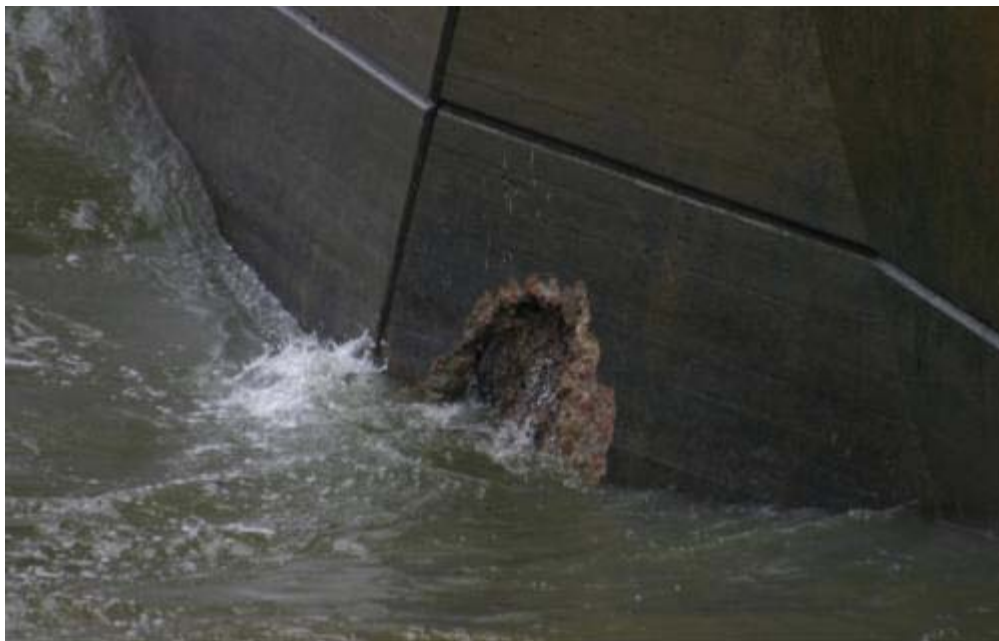
**Figure 96. Dams damage/erosion: Fort Randall - Downstream spillway wingwall concrete spall at Fort Randall, South Dakota**

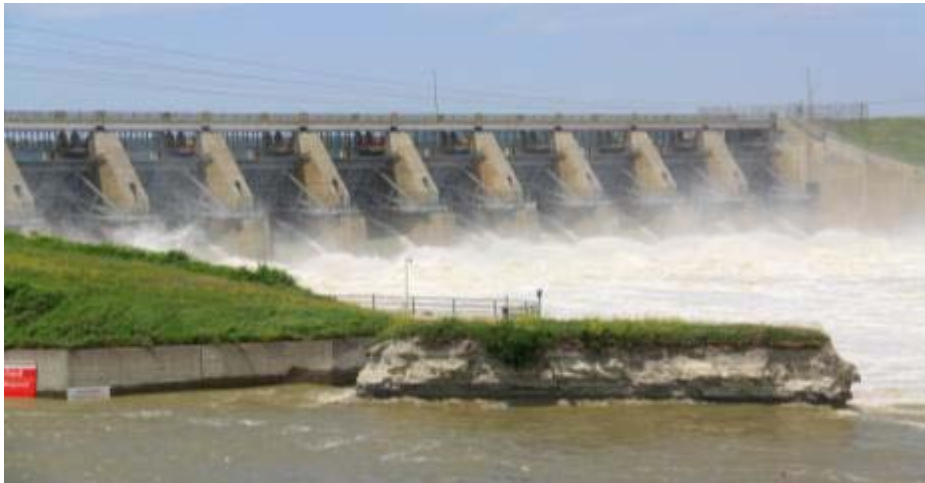
**Figure 97. Dams damage/erosion: Gavins Point - Erosion on earthen walls of the project's spillway in South Dakota**

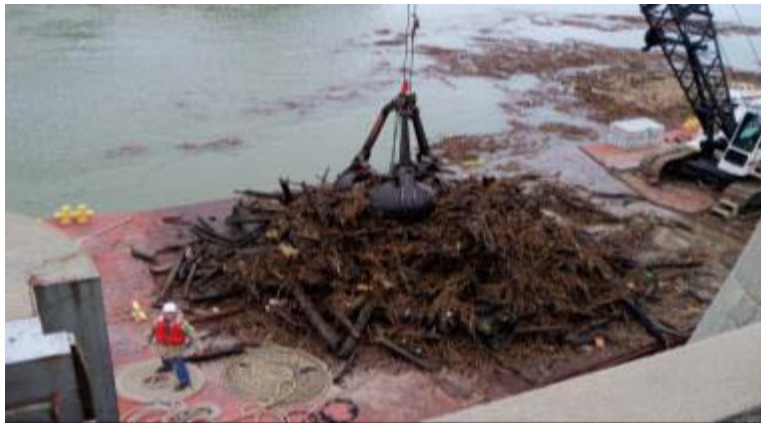
**Figure 98. Dams damage/erosion: Gavins Point - Excess debris led to clogging of water intake at Hydropower Plant (under repair) in South Dakota**

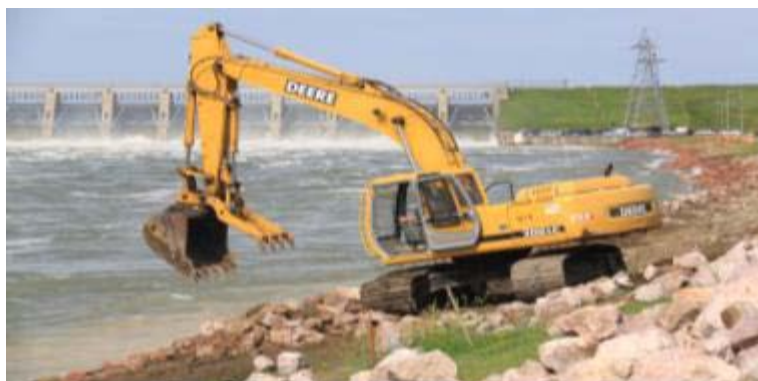
**Figure 99. Dams damage/erosion: Gavins Point - Erosion on earthen walls of the project's spillway in South Dakota (under repair)**

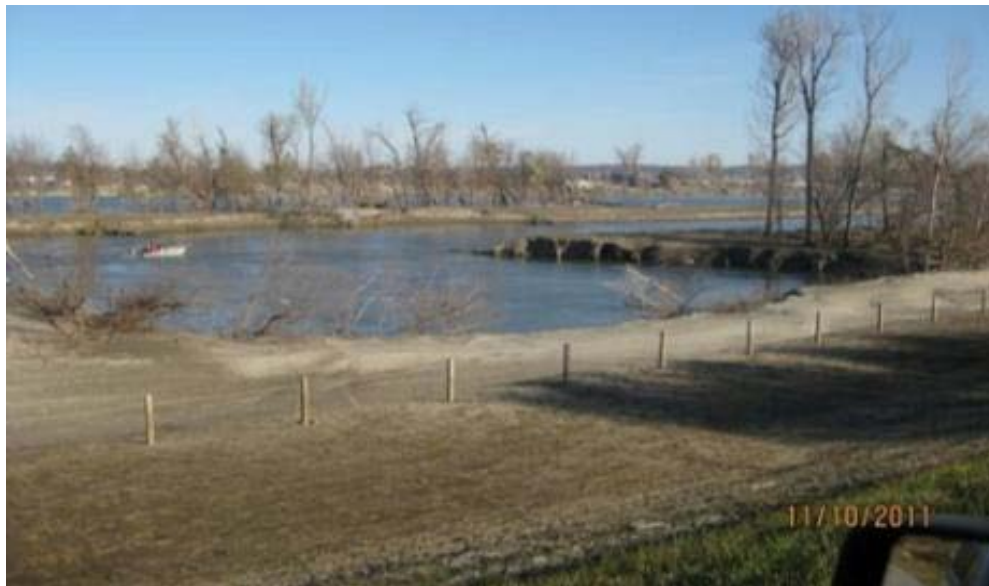
**Figure 100. Levee scouring/erosion: Scour hole between Council Bend chute and MR Levee L624-627 toe in Council Bluffs, Iowa**

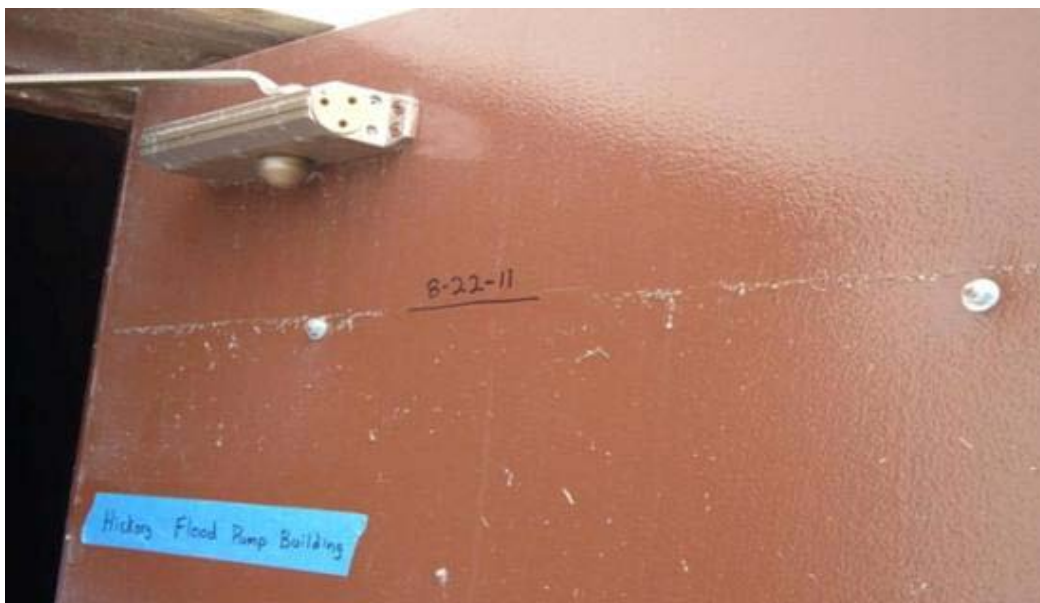
**Figure 101. Flood protection project damage: Hickory Street Pump Station - High water mark on interior side of an exterior door at a flood protection project in Omaha, Nebraska**

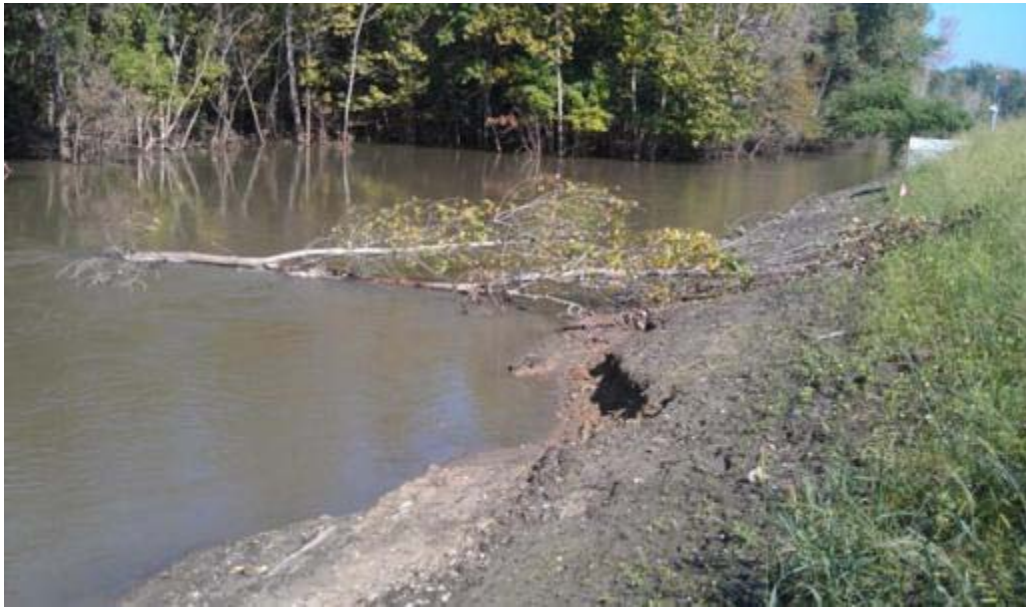
**Figure 102. Levee scouring/erosion: Typical riverside erosion and vegetation loss at L611-614 near Council Bluffs, Iowa**

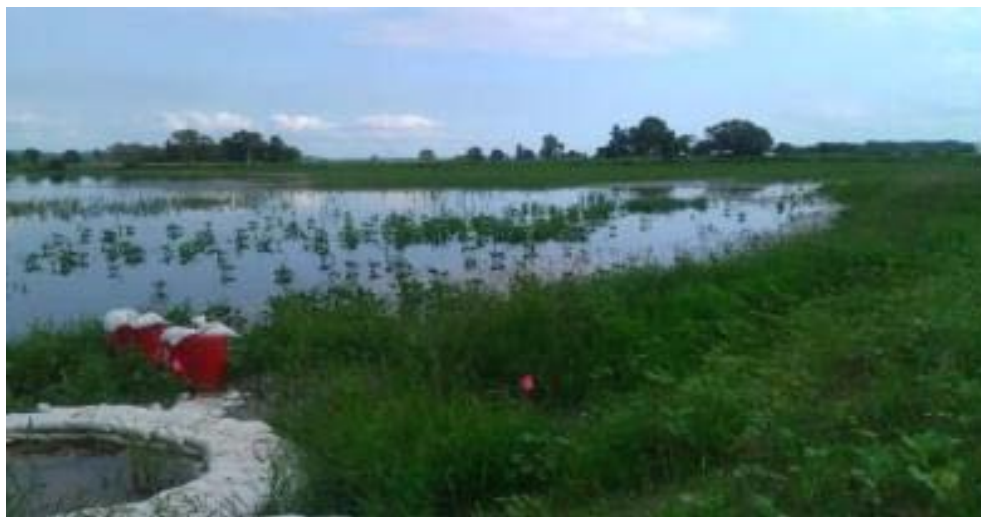
**Figure 103. Levee seepage/sandboils: Typical landside seepage and sandboils at L611-614 near Council Bluffs, Iowa**

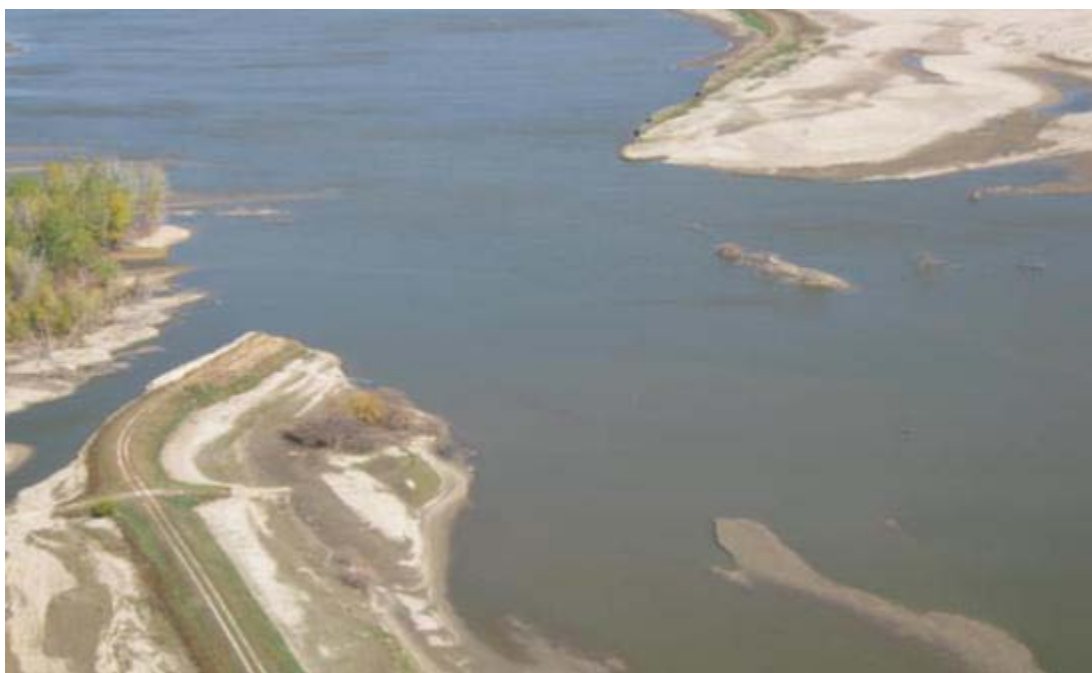
**Figure 105. Levee breach: Upper breach at L575**

Levee breach of L575 on Missouri River seen as waters have receded significantly.

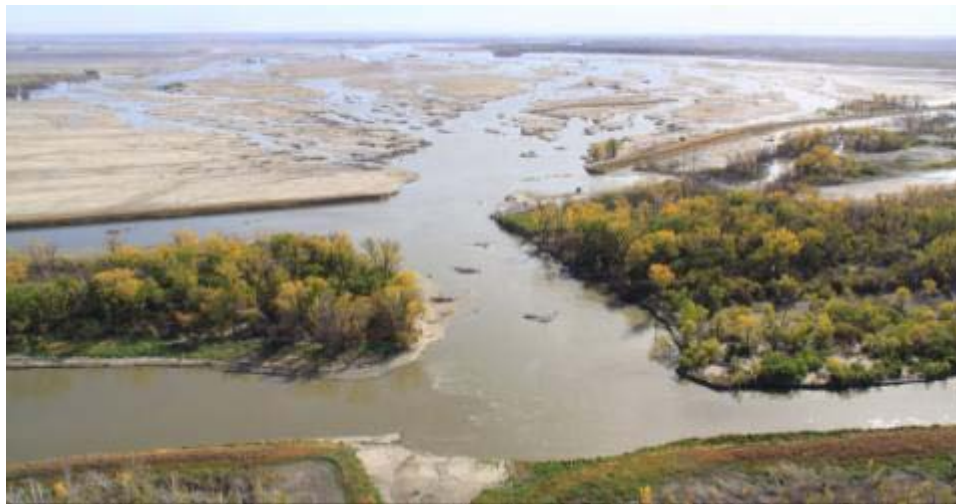
**Figure 106. Levee breach: Middle breach at L575**

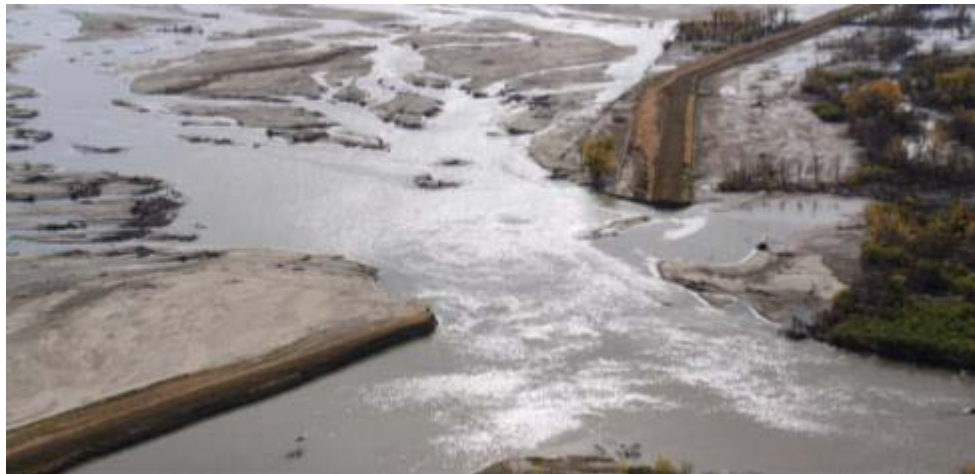
**Figure 107. Levee breach: Middle breach at L575**

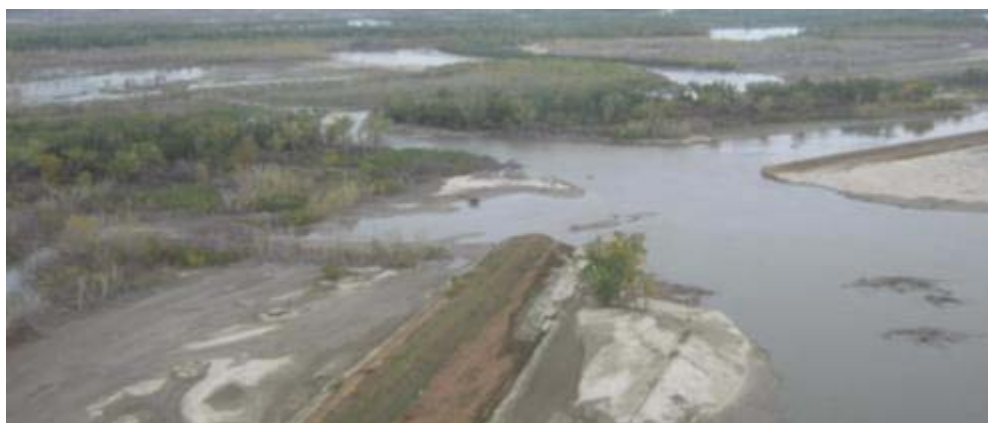
**Figure 108. Levee breach: Middle breach at L575**

The middle levee breach of L575 on Missouri River seen as waters have receded significantly.

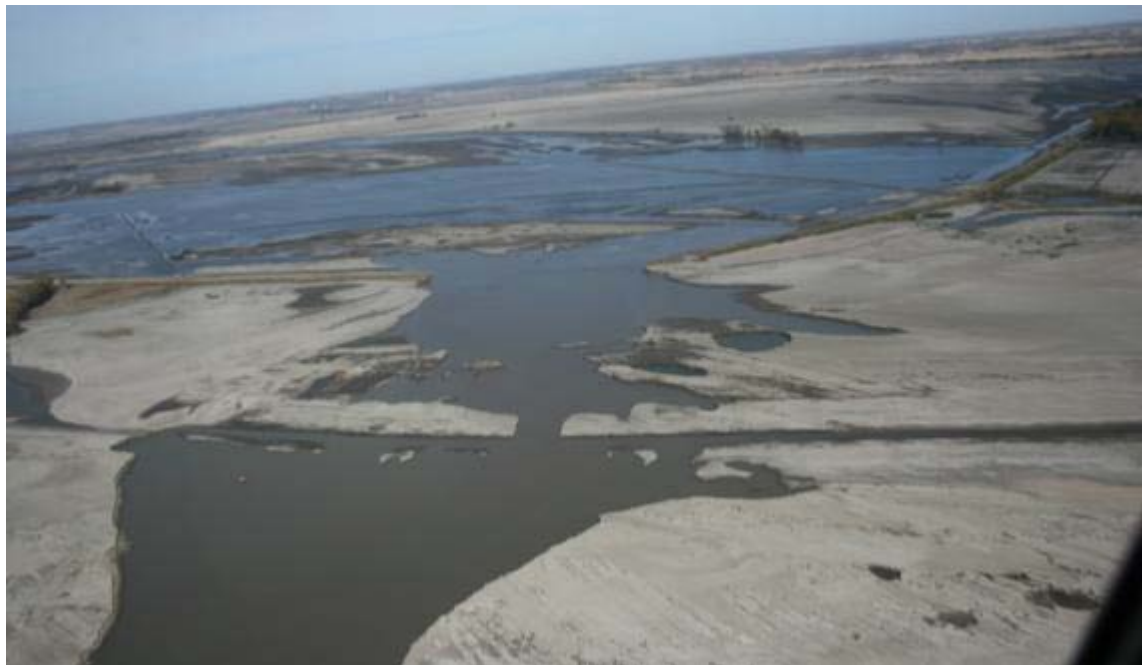
**Figure 110. Levee breach: Lower breach at L575**

The lower levee breach of L575 on Missouri River seen as waters have receded significantly.

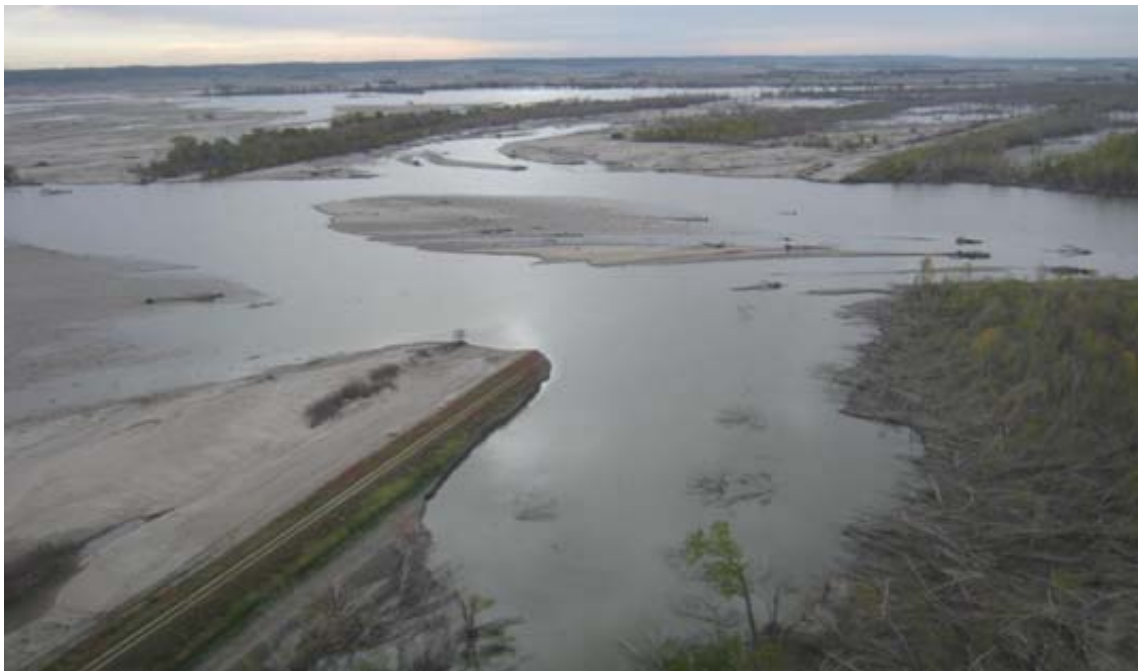
**Figure 111. Levee breach: Upper breach at L550**

The upper levee breach of L550 on Missouri River seen as waters have receded significantly

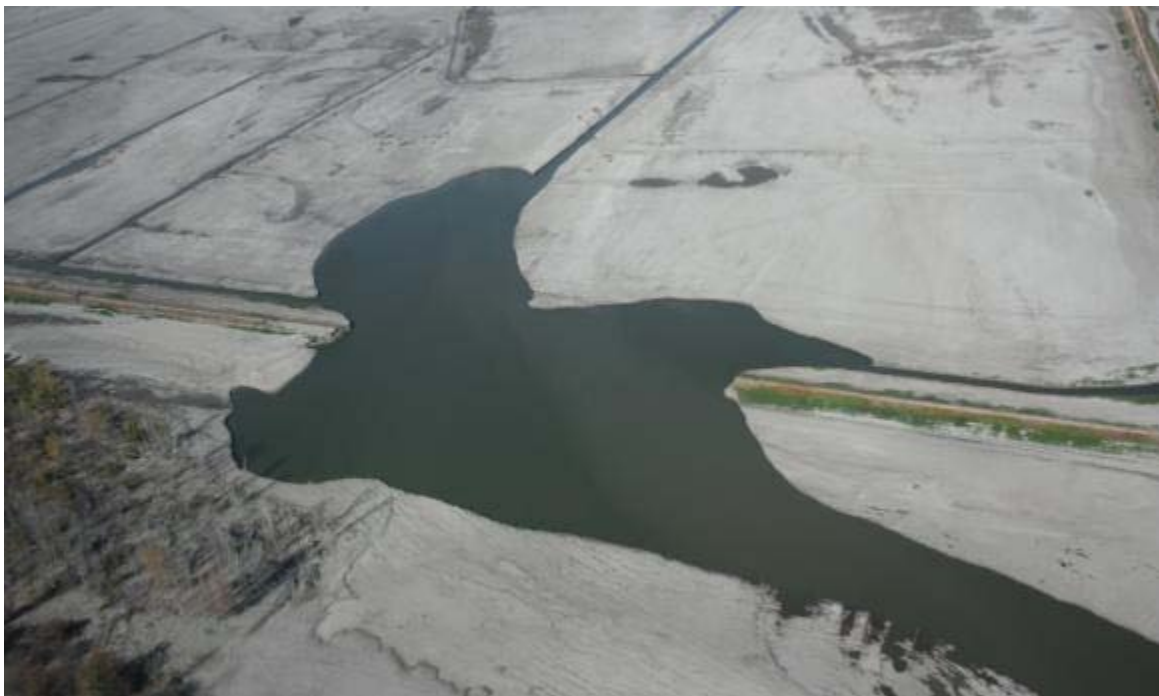
**Figure 112. Levee breach: Lower breach at L550**

The lower levee breach of L550 on Missouri River seen as waters have receded significantly.

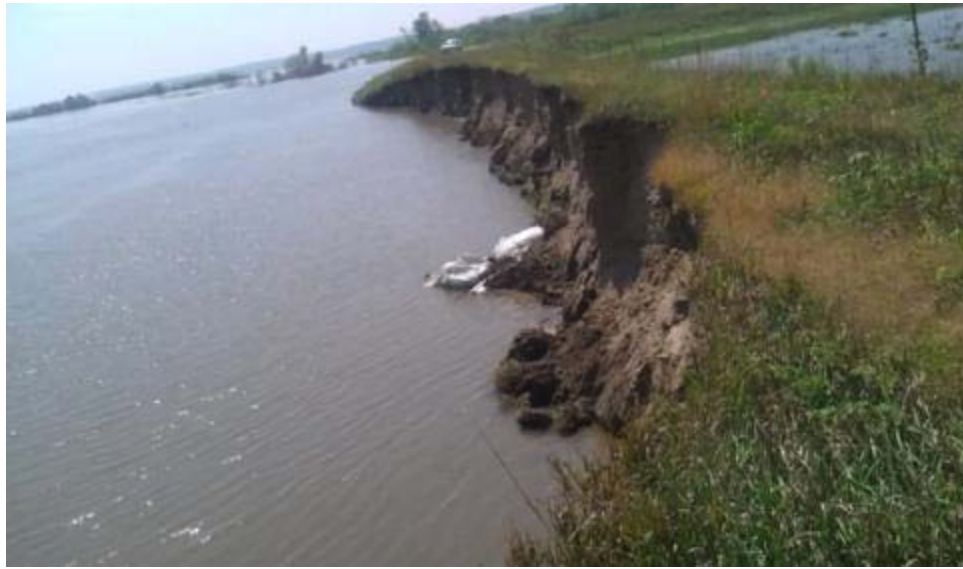
**Figure 113. Levee scouring/erosion: L536 - Levee erosion – more than 50 percent of the embankment is missing – at MR Levee L536**
